WA-I-504 Frame Farmhouse

Hagerstown Vicinity

Maryland Historical Trust State Historic Sites Inventory Form

WA-I-504

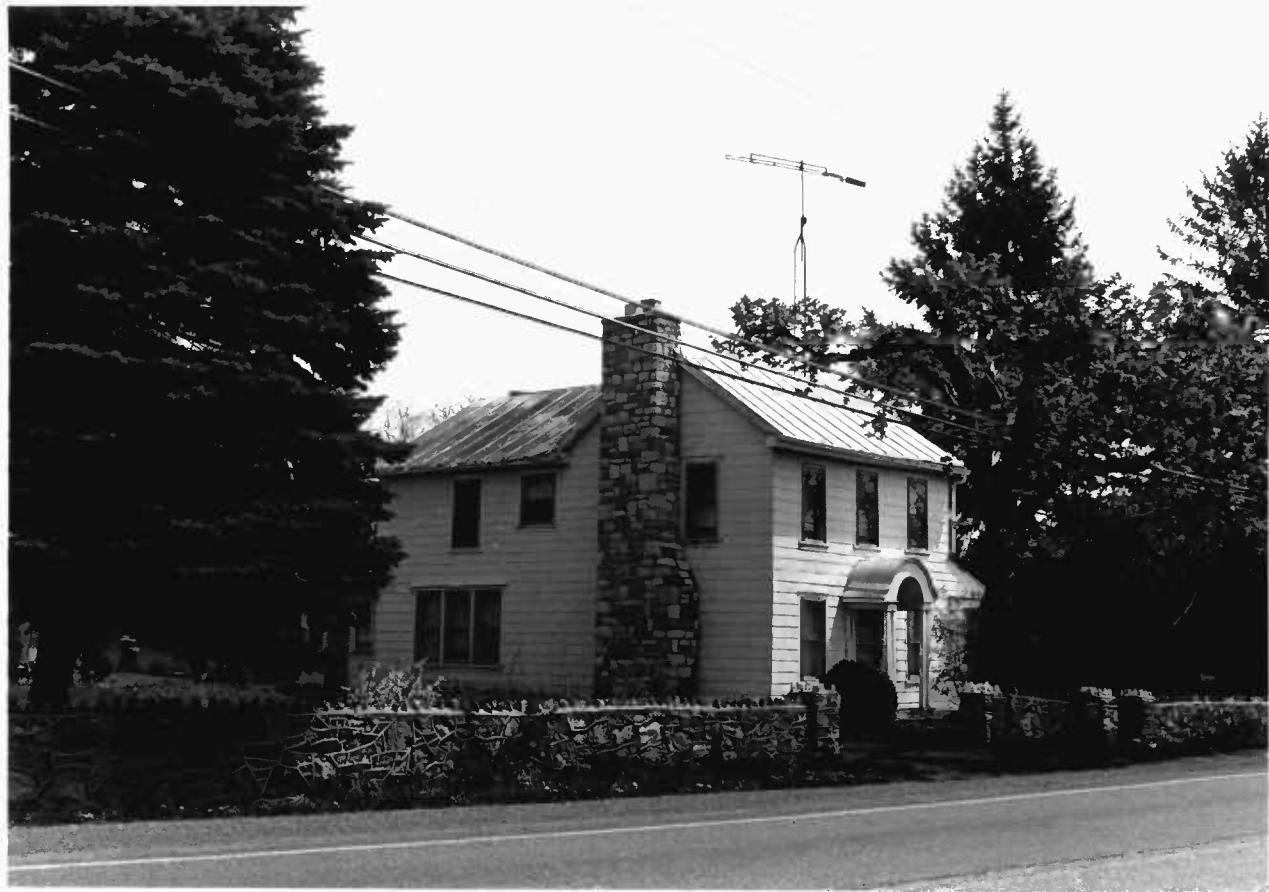
1. Frame Farmhouse WA-I-504
2. Washington County, Maryland
3. Joe Getty
4. May 1983
5. Maryland Hist. Trust, Annapolis, Md.
6. North & West elevations; camera facing
South East
7. 1/2

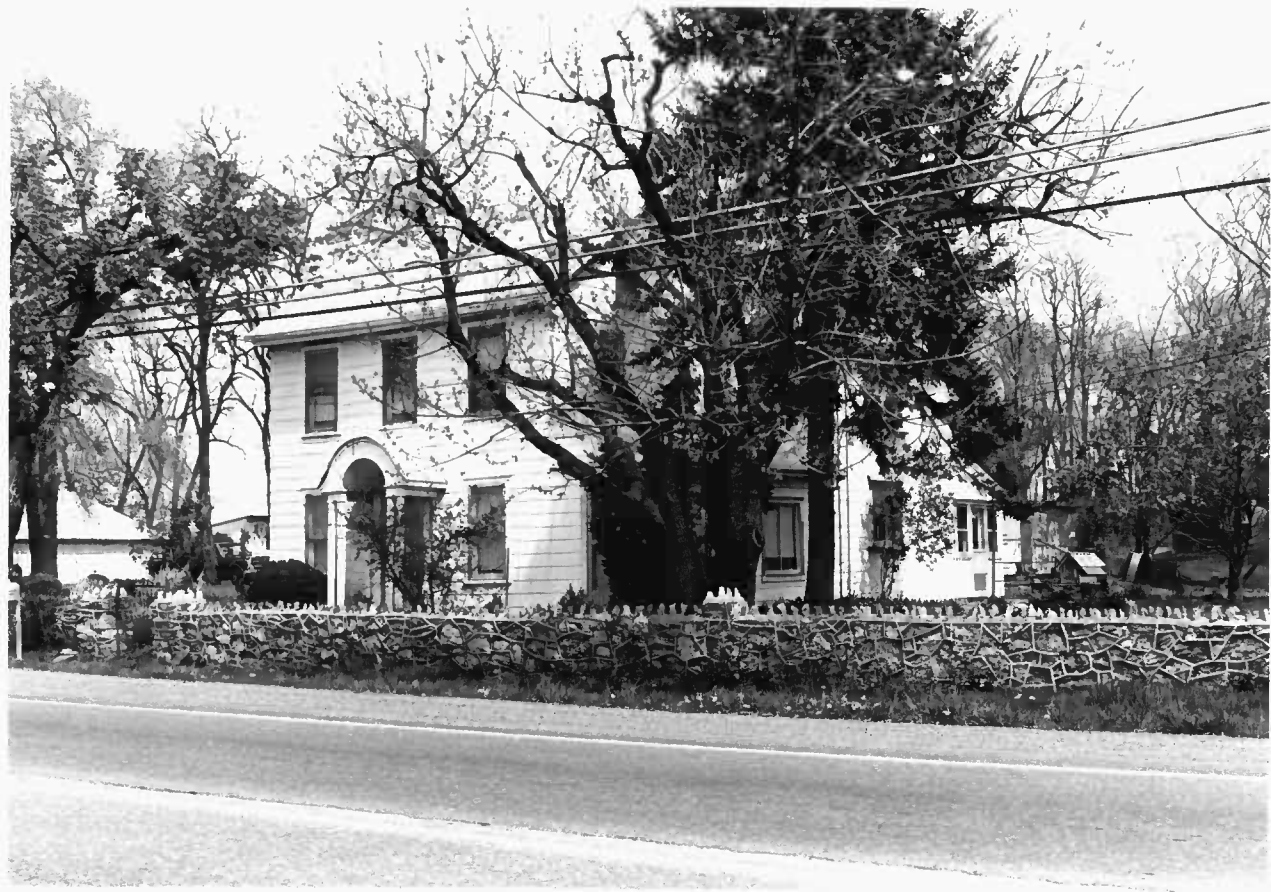
1. Frame Farmhouse WA-I-504
2. Washington County, Maryland
3. Joe Getty
4. May 1983
5. Maryland Hist. Trust, Annapolis, Md.
6. South & West elevations; camera facing
north east
7. 2/2
